REPORT OF TEST

Test Procedure: *UL 1715 - Fire Test of Interior
Finish Material*

Report No.: 126659

SUBJECT: Testing Flammability to UL 1715, Fire Test of Interior Finish Material.

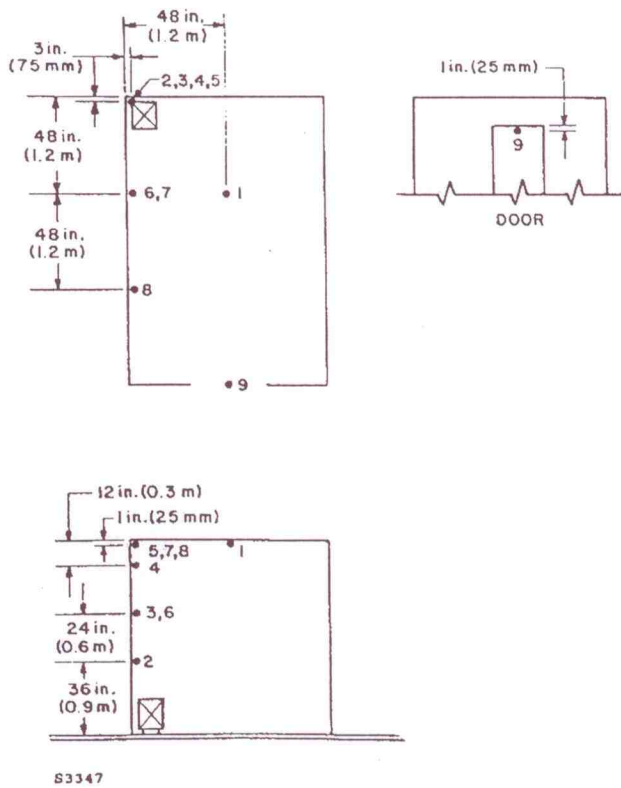
Temperatures	616 °F (Thermocouple #9)	Maximum allowed: N/A
	268 °F (Thermocouple #6)	Maximum allowed: N/A
	1644 °F (Thermocouple #3)	Maximum allowed: N/A
	1659 °F (Thermocouple #2)	Maximum allowed: N/A
	498 °F (Thermocouple #8)	Maximum allowed: N/A
	642 °F (Thermocouple #1)	Maximum allowed: N/A
	878 °F (Thermocouple #7)	Maximum allowed: N/A
	1337 °F (Thermocouple #5)	Maximum allowed: N/A
	1359 °F (Thermocouple #4)	Maximum allowed: N/A

**FIGURE 9.1
THERMOCOUPLE LOCATIONS**

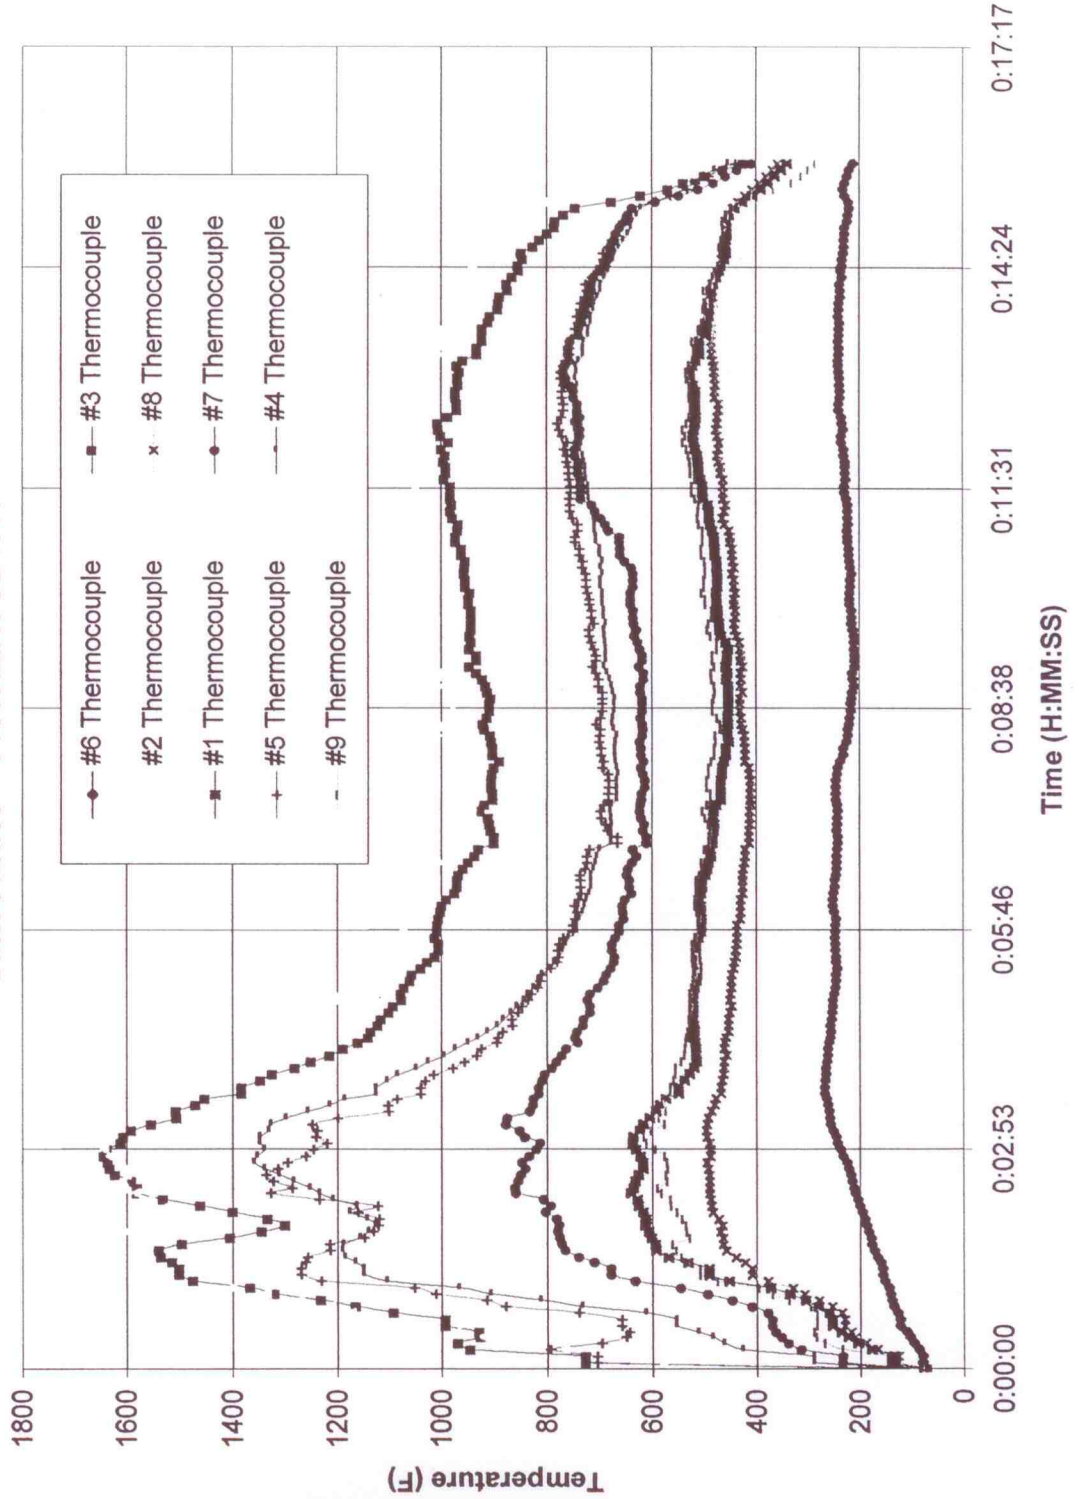
Temperature Vs. Time
Client: Illbruck, Inc. Job# 126659
Date: 6/24/99 Procedure: UL 1715

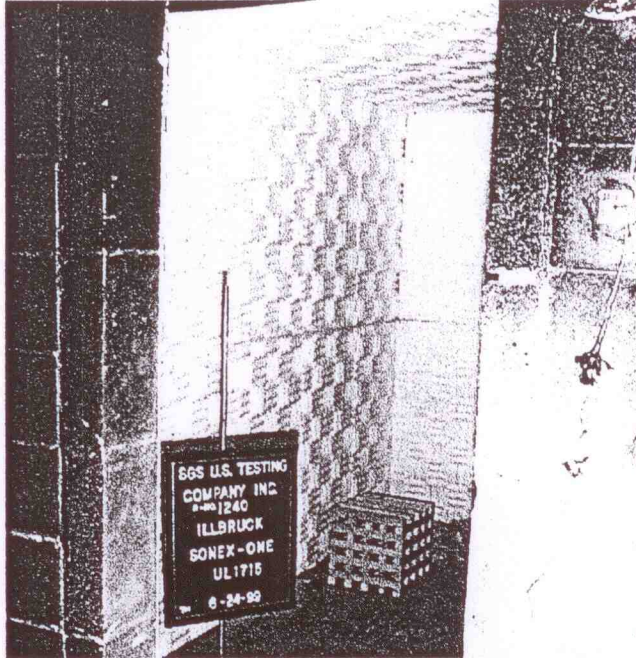
PHOTO 1. Photo of Installation of 'Sonex-One'

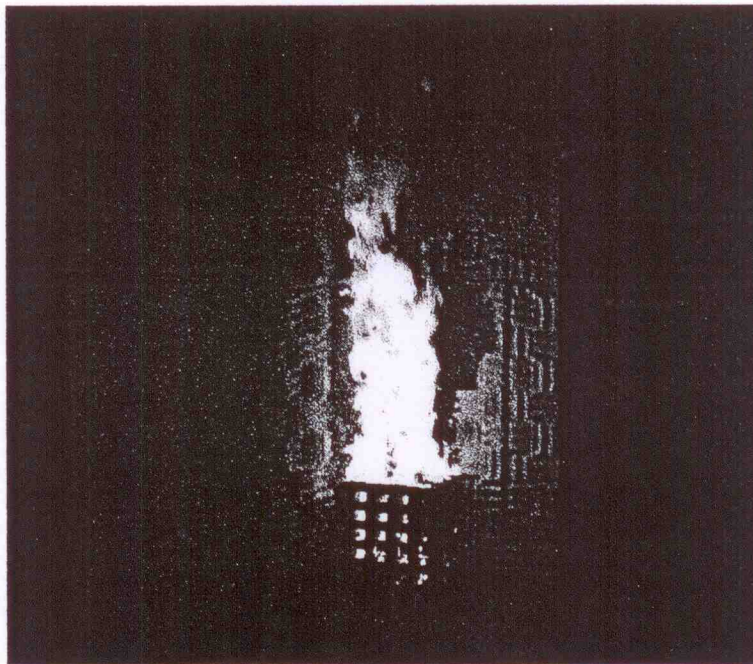
PHOTO 2. Maximum Involvement of Crib

- 0:00:00 – Ignition of crib
- 0:00:10 – Flaming of material reached ceiling – Flame front did not continue to the horizontal wall and ceiling seams
- 0:01:30 – White smoke generated by material covering 6 ft level
- 0:02:15 – First signs of significant charring of material
- 0:03:25 – Ceiling material (above crib) penetrated by flame
- 0:04:20 – Smoke significantly reduced in room (burning of material had minimized)
- 0:10:00 – Charring is ranging within 2 feet on both walls of the vertical corner (adjacent to the crib location)
- 0:10:15 – Sample shows signs of adhesion failure due to elevated temperatures
- 0:15:10 – Testing was stopped (extinguished)

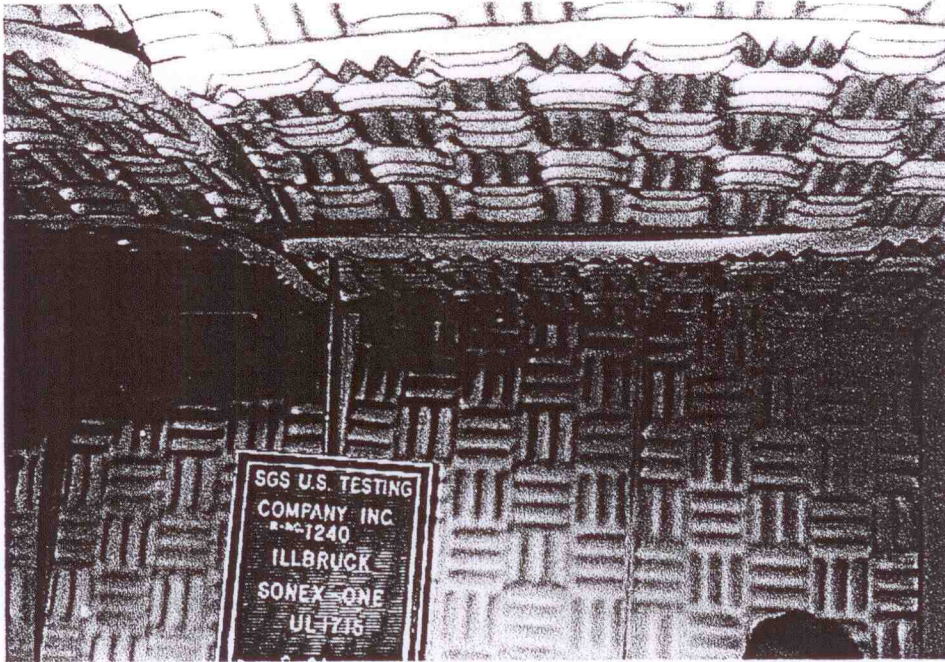
PHOTO 3. 8 ft Wall Charring

Measurements of Charring: *(See photos 3, 4)*

- * Along 12 ft wall – 6 ft 3 in
- * Along 8 ft wall – 6 ft 7 in
- * Diagonal across ceiling (from corner) – 5 ft 7 in

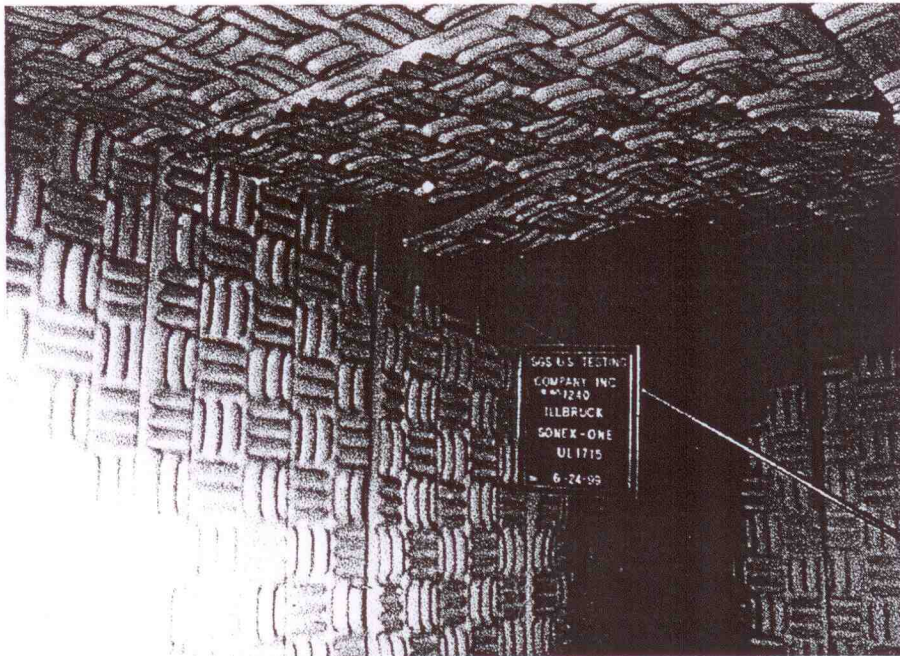
PHOTO 4. 12 ft Wall Charring

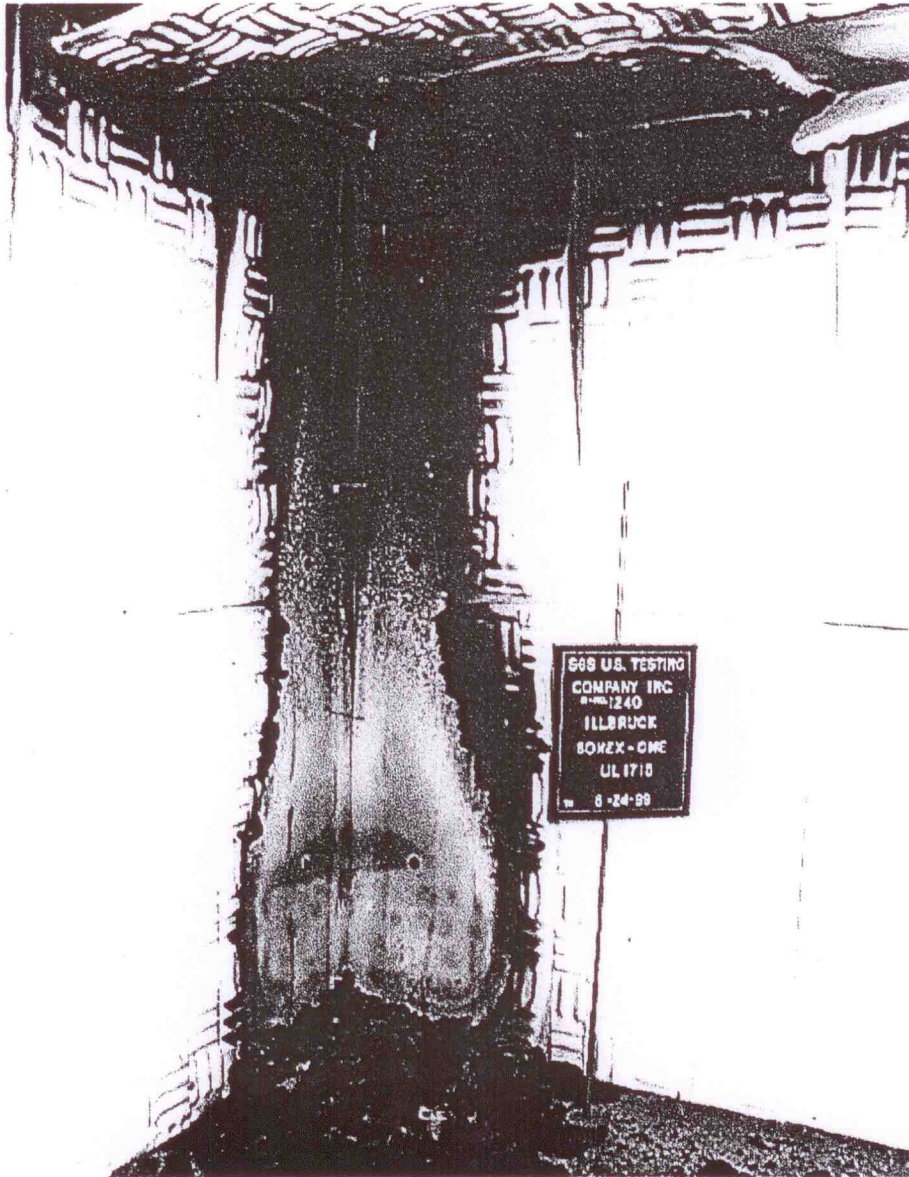
PHOTO 5. Sonex-One after UL 1715 Fire Test
